NASA Contractor Report 181945

**DEVELOPMENT AND FABRICATION OF STRUCTURAL
COMPONENTS FOR A SCRAMJET ENGINE**

**Contract NAS1-16097
March 1990**

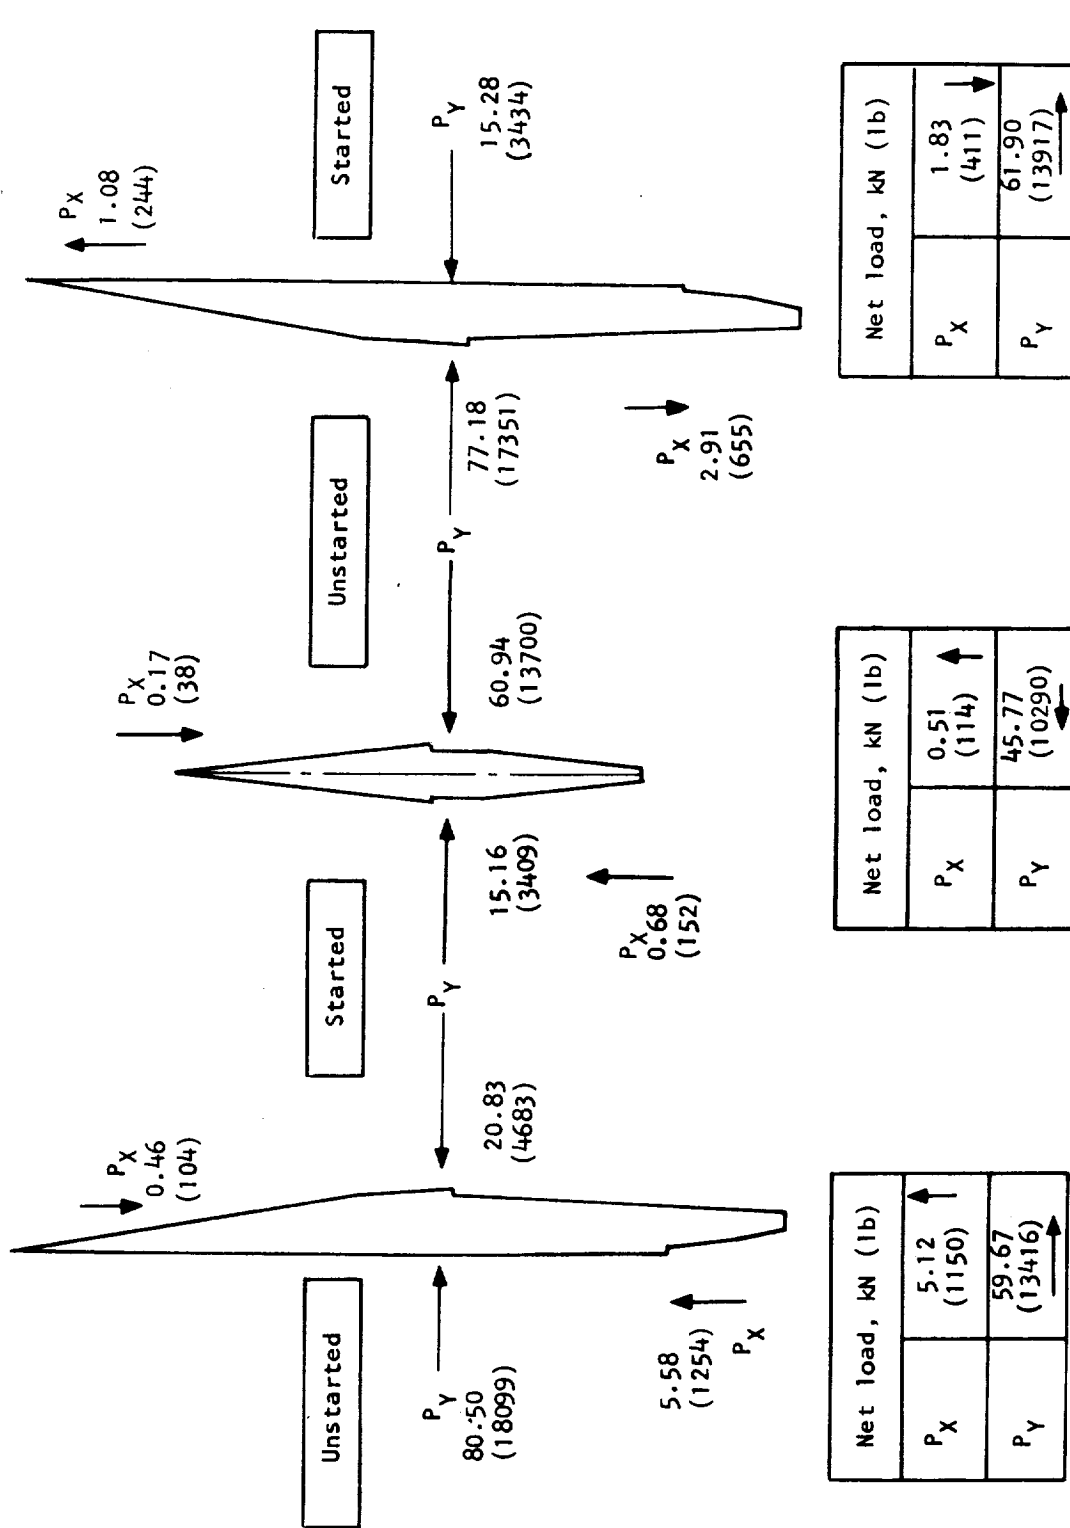
Figure 4. Strut Loads, Transient Unstart Conditions

Figure 4 (taken from ref. 2) shows the design pressure loads used for the struts, based on the assumption of an asymmetrical engine unstart at $M = 5.1$. This condition was used because it is the most severe aerodynamic loading. The high net load on the side strut led to its selection for this program. Figure 5 (from ref. 2) shows the heating rates used in the design, taken at the $M = 10$ operating condition. This is the highest thermal loading and served to define the cooling requirements, and the creep-rupture and low-cycle-fatigue performance. Although the heating rates are somewhat lower for the side strut than for the center strut, the side strut was judged the most severe combined-load case. Tables 2 and 3 list the heat loads and fluxes for both kinds of struts.

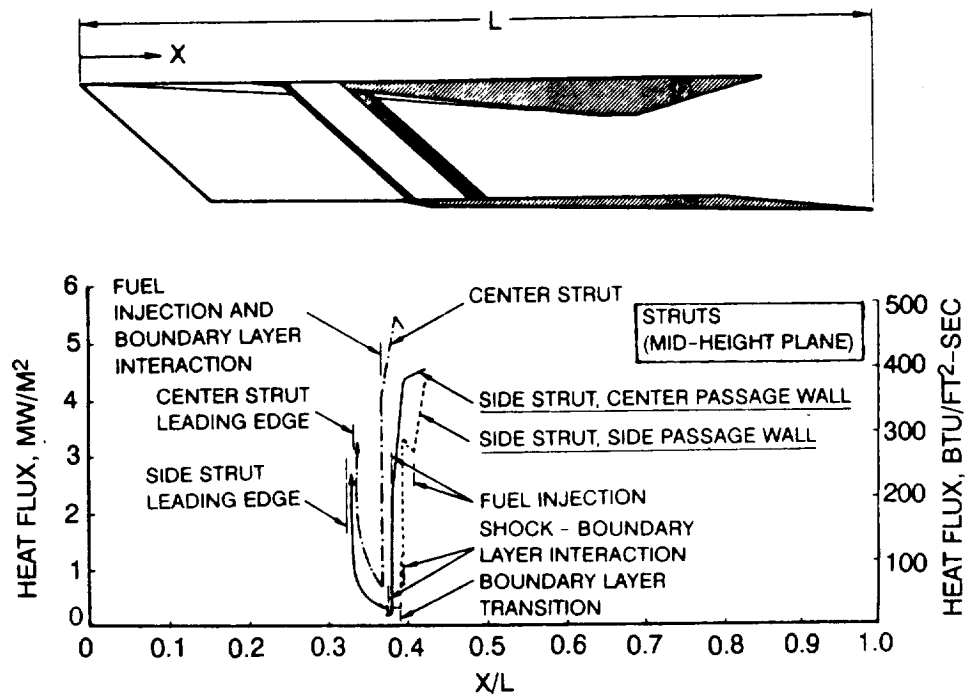
Figure 5. Aerodynamic Heating Rates on Fuel Injection Struts at Maximum Heating Condition (Reference 2)

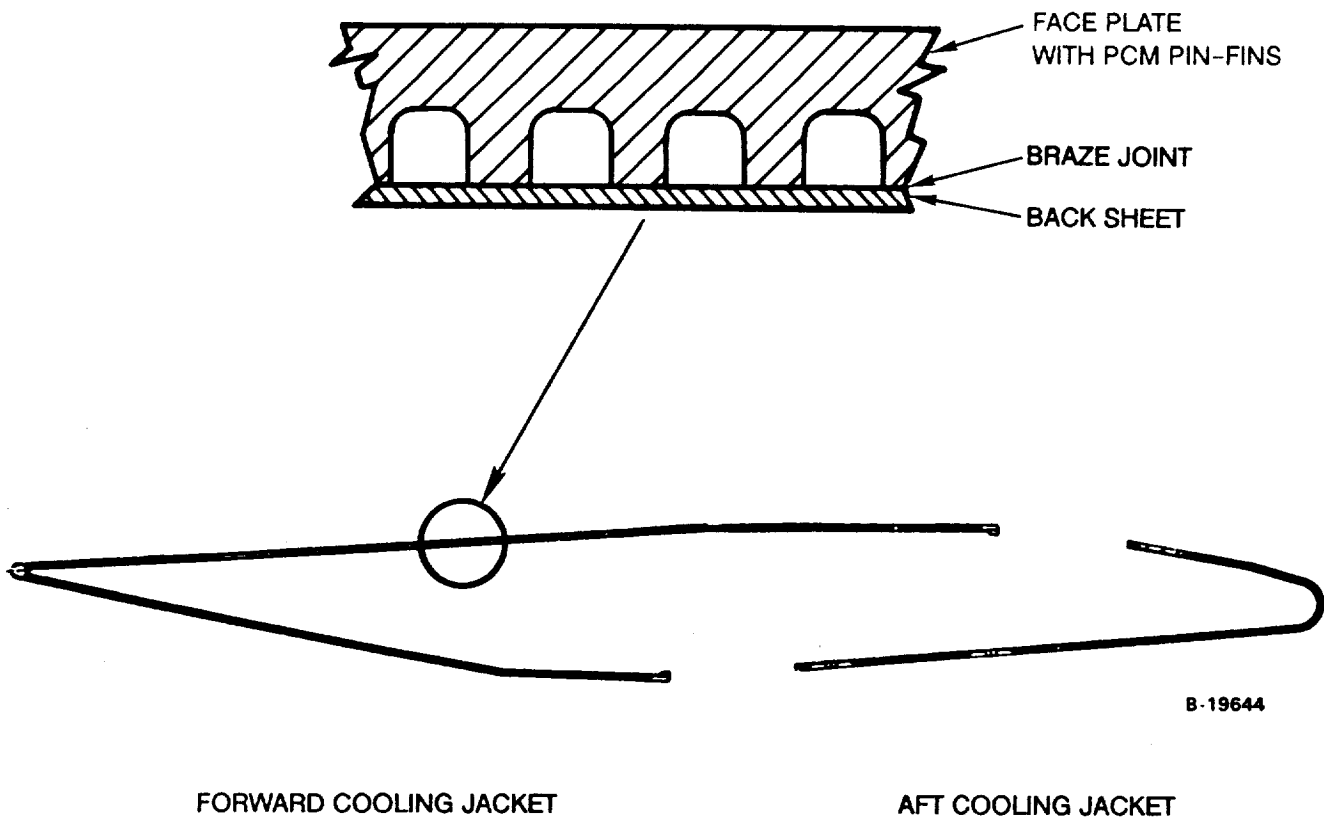
- SINGLE SANDWICH CONSTRUCTION
- PCM PIN-FIN COOLANT PASSAGE
- Ni-201 PIN-FIN SHEET 0.035 IN.
- Ni-201 BACK SHEET 0.010 IN.
- 50% Au-25% Pd-25% Ni (PALNIRO 1) 0.0015-IN. BRAZE FOIL
- BRAZE IN VACUUM BAG (2070°F)
- HOLOGRAPHIC PRESSURE TEST

Figure 13. Jacket Assembly

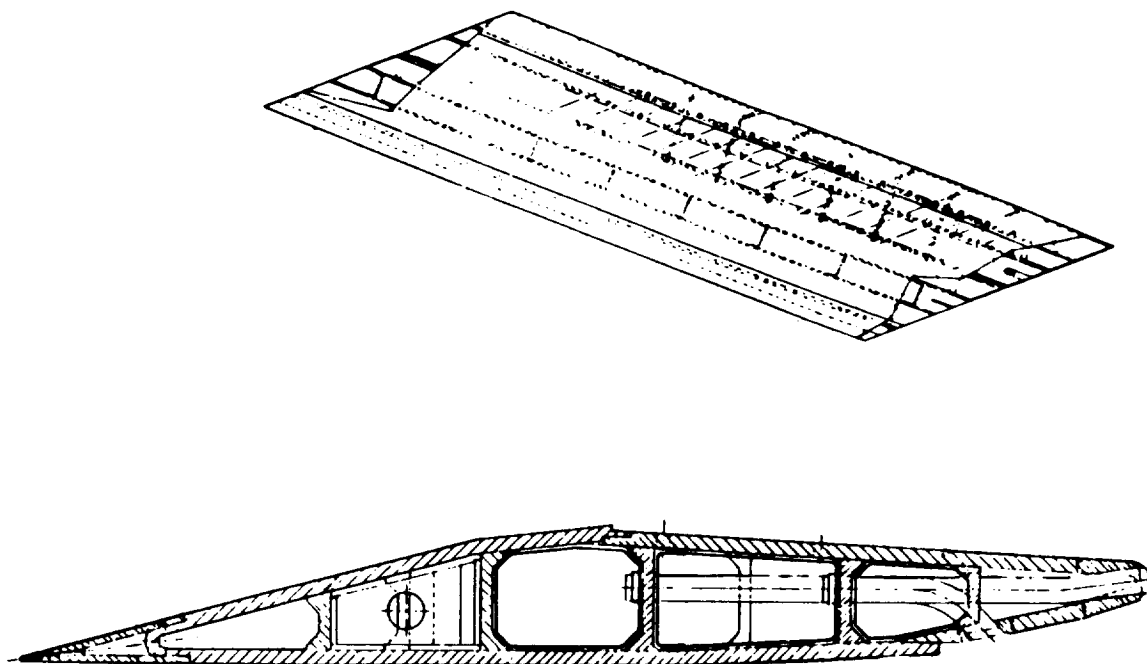
- INCONEL 718 BEAMS AND WALLS
- TYPE 347 STAINLESS STEEL BUFFERS
- 50 Au, 25 Pd, 25 Ni (PALNIRO 1) 0.001-IN. BRAZE FOIL
- BRAZE IN VACUUM BAG (2070°F)
- AGE HARDEN
- HOLOGRAPHIC PRESSURE TEST

Figure 14. Support Structure Assembly

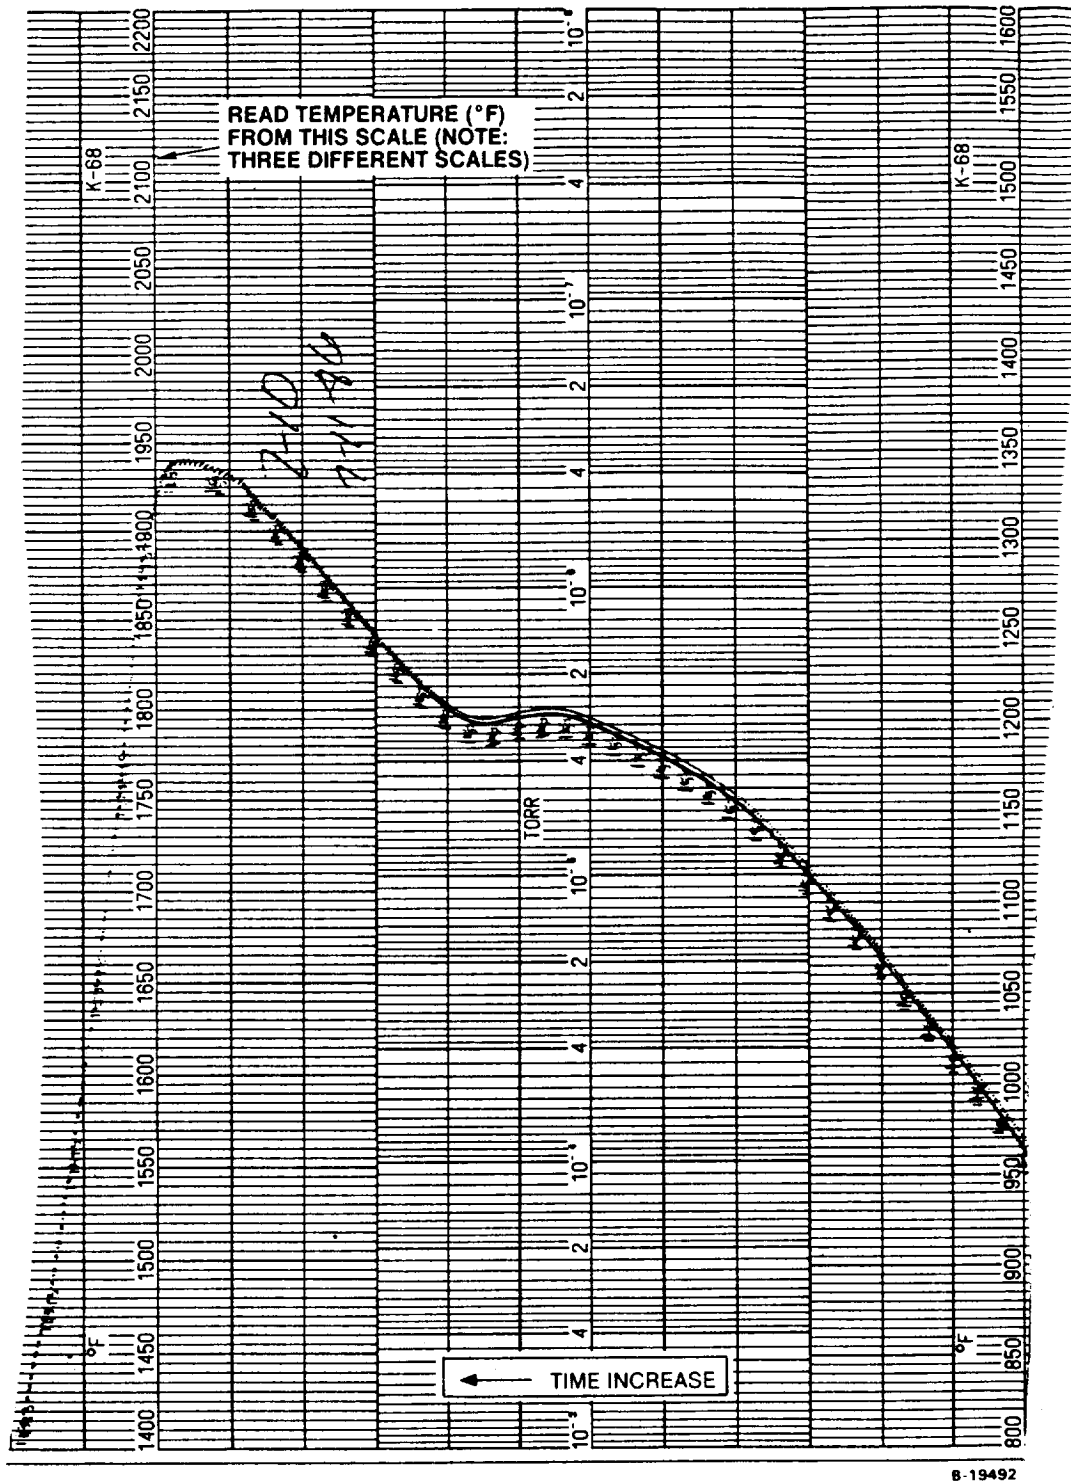
Figure 19. Braze Cycle Temperature History for PL Cooling Jacket-to-Support Structure with Palnir 7 Filler Alloy

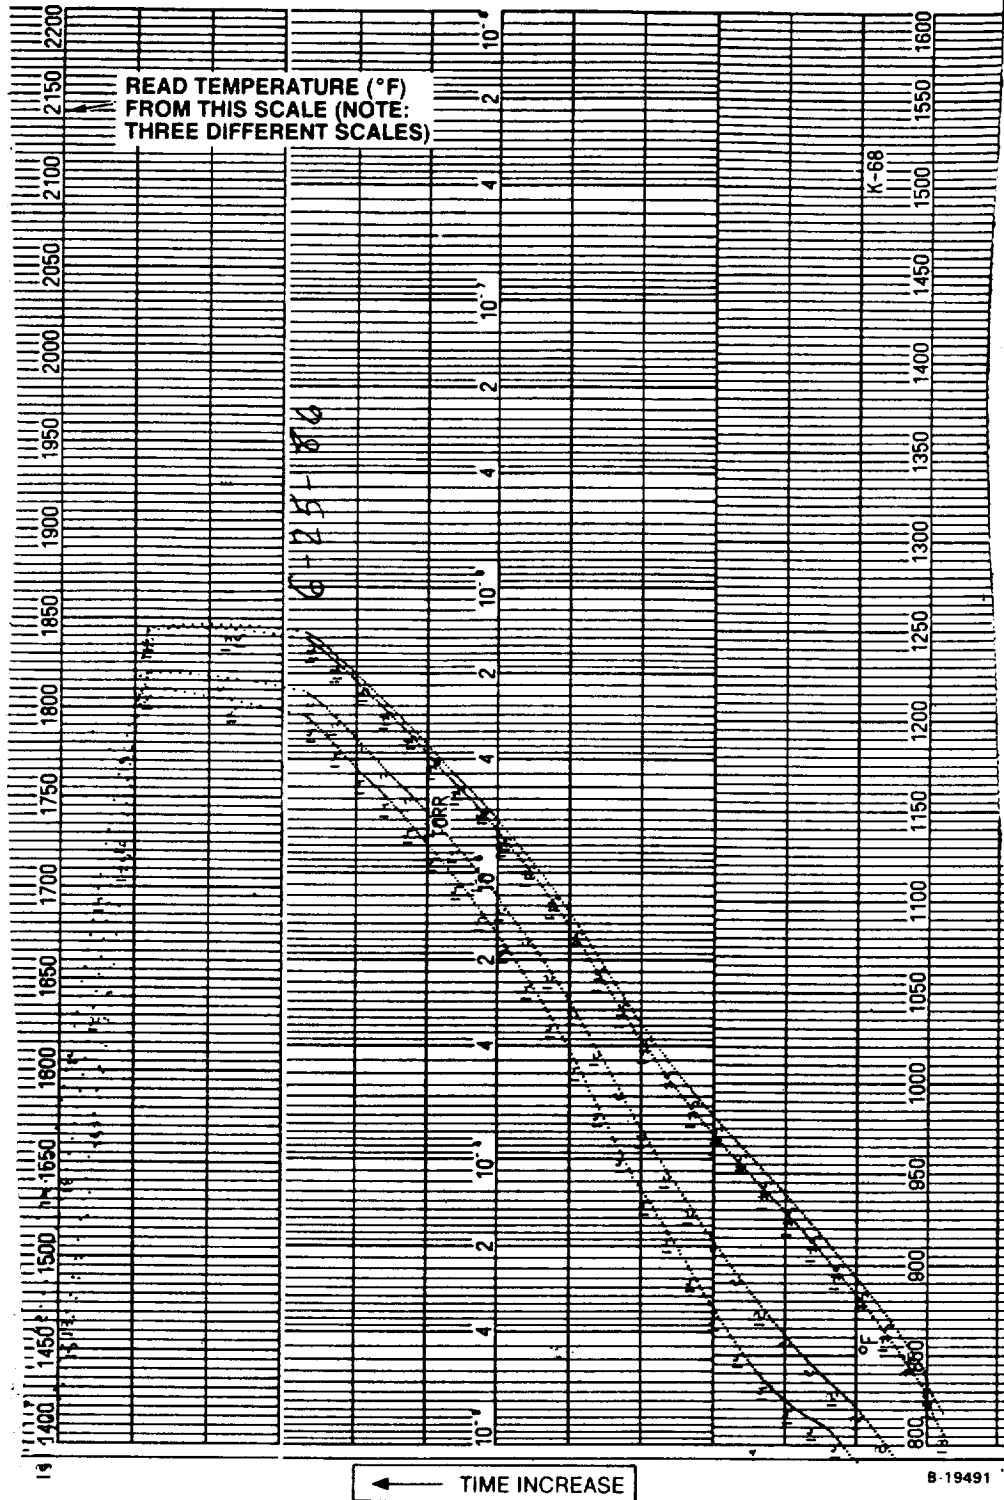
Figure 20. Braze Cycle Temperature History for PL Strut Cover Plate—Support Structure with Niore Filler Alloy

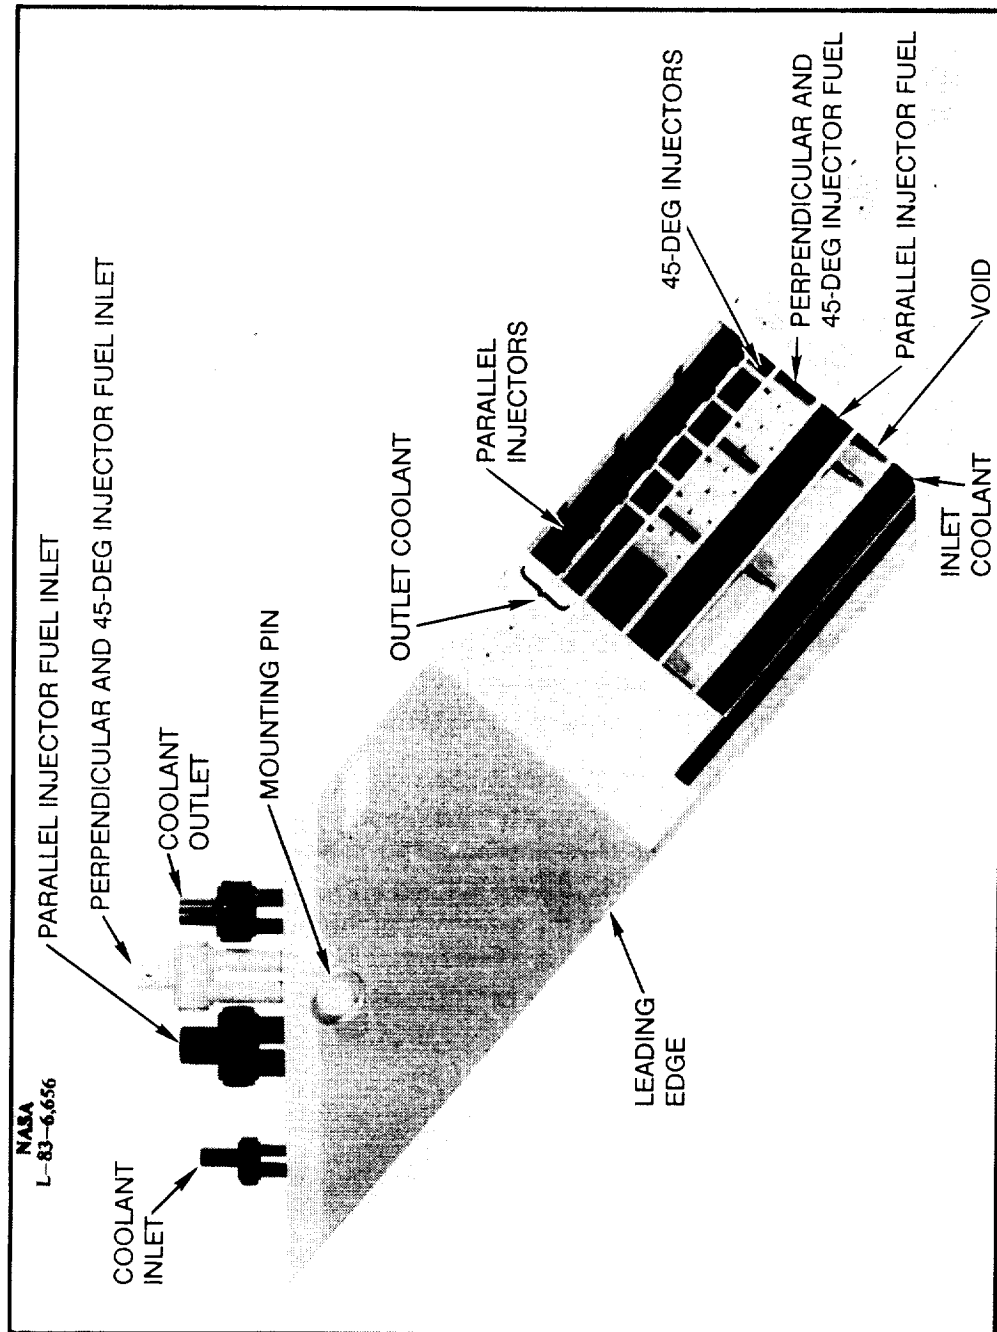
Figure 21. Strut Assembly Model

The design provides for independent fabrication of the cooling jacket and support structure as the forward and aft sections. Fabrication of the formed support structures involved grinding the material blanks flat to final thickness, brake forming to the general shape of the wall contour, and hot forming the rough shaped walls into the precise shape for brazing the walls and bulkheads (wire EDM was used to generate the hot forming mandrel). After final machining, the Inco-718 support-structure elements were braze-assembled in a single operation.

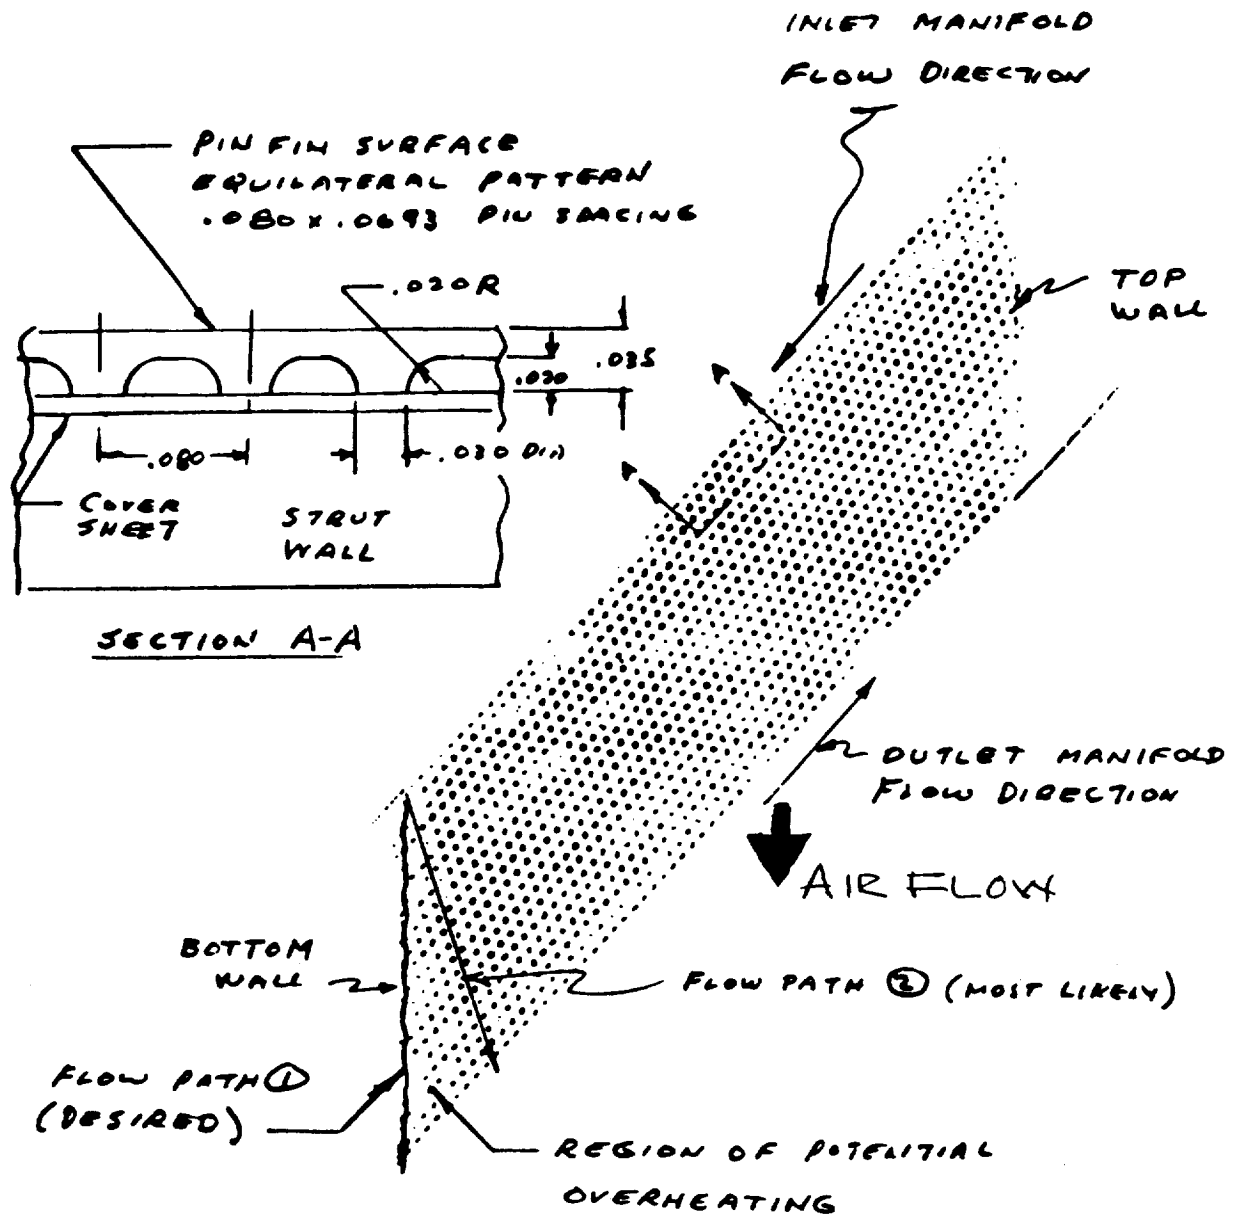
Figure 25. Pin-Fin Coolant Surface

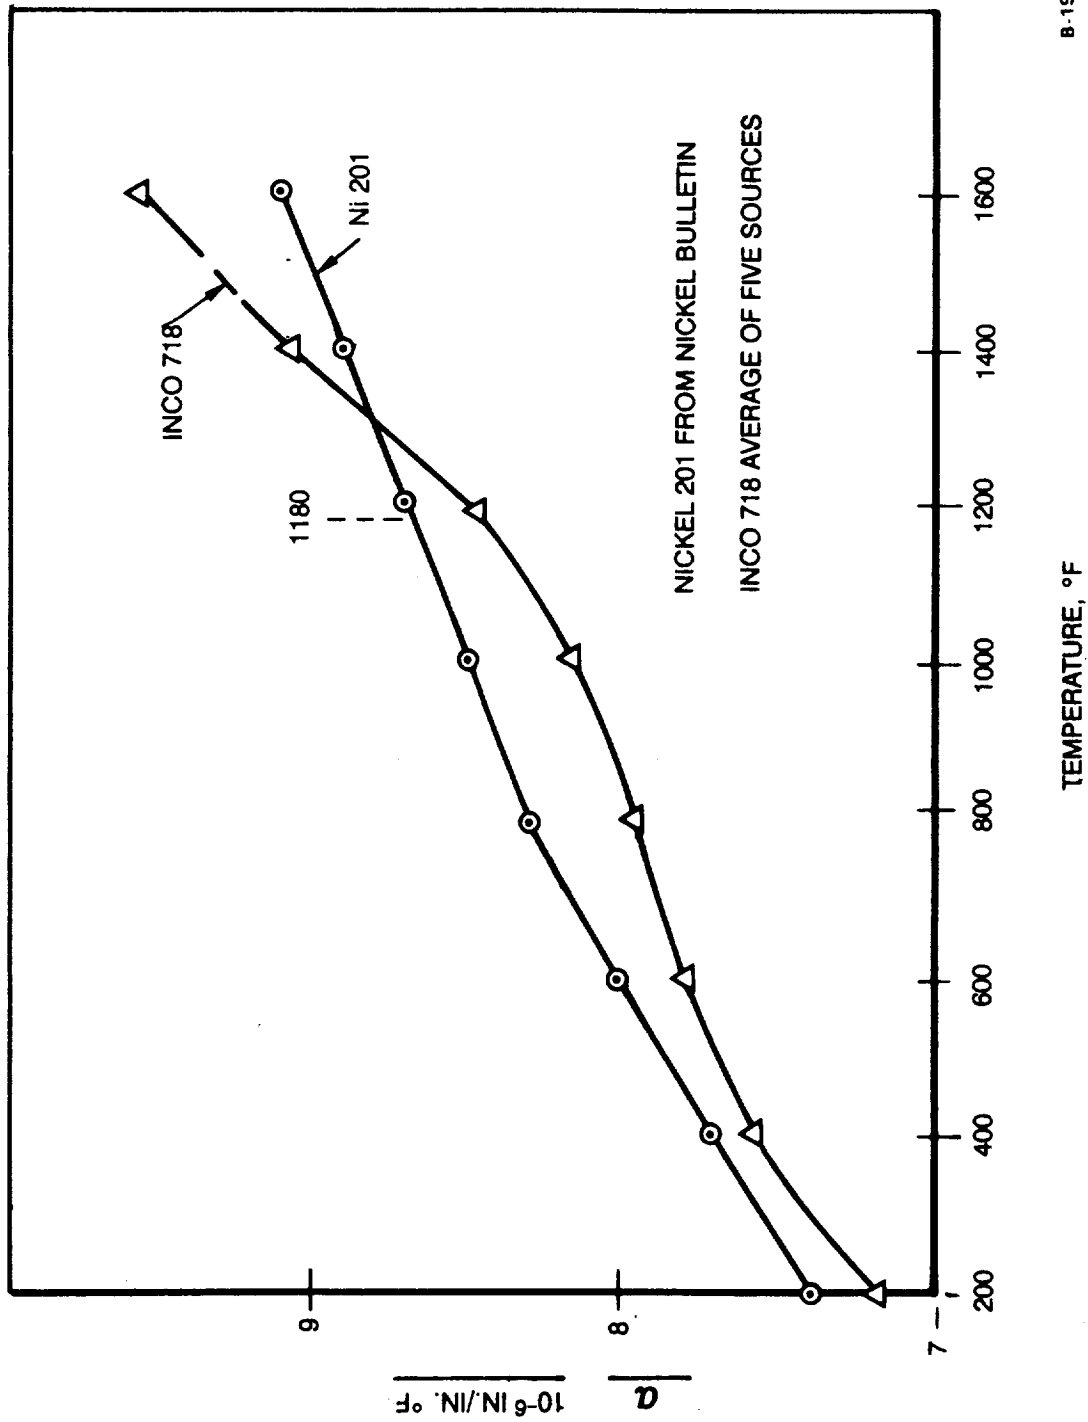
Figure 28. Coefficient of Thermal Expansion (α) for Nickel 201 and Inconel 718

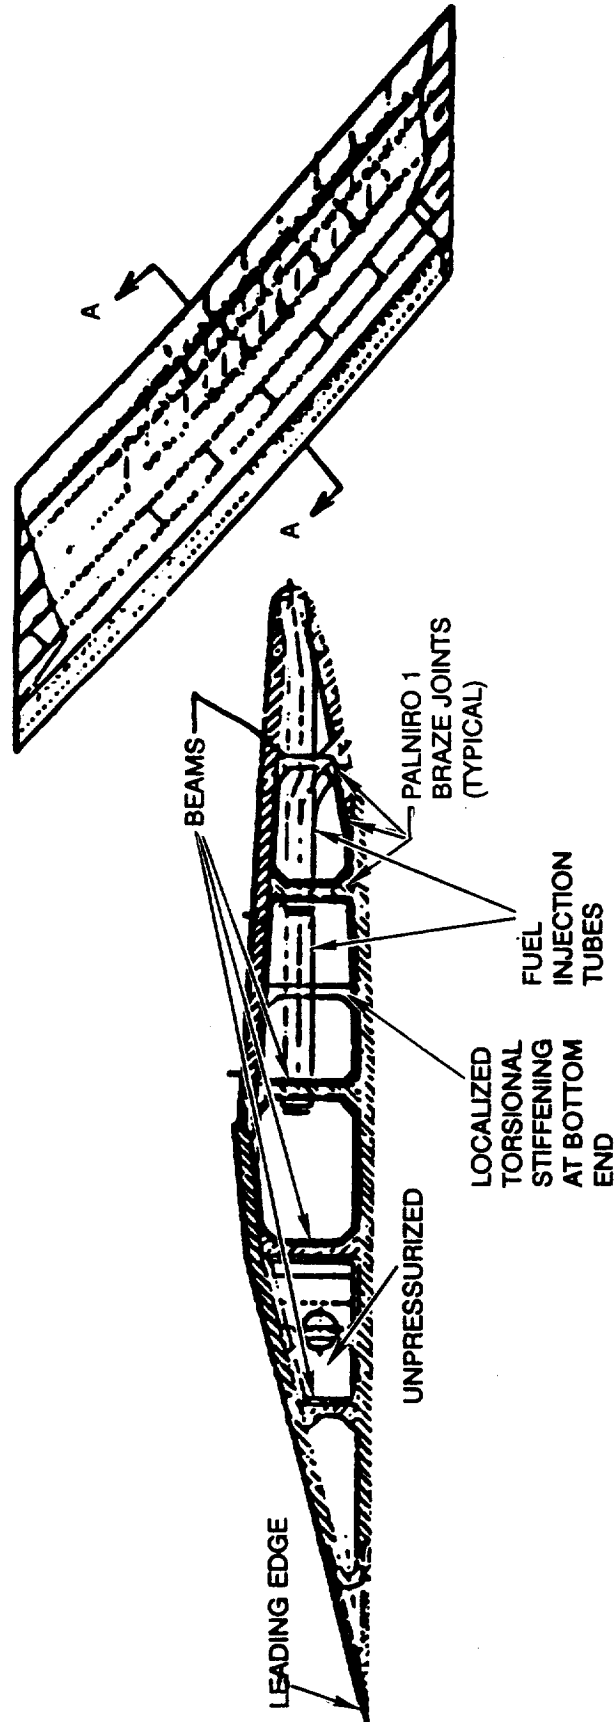
Figure 29. Strut Configuration for First Braze Cycle

Palniro 1 braze filler alloy is placed in all of the joints prior to vacuum brazing at 2080°F. The aft three beams are penetrated by fuel injection tubes, and in the aft-most beam, the penetrations cause the braze joint on one side to be interrupted along the length. Braze assembly of the cooling jackets follows strut body brazing and is with Palniro 7 filler alloy at 1935°F, as shown in Figure 12. The top and bottom ends of the strut are closed by flat plates that are brazed to the assembly with Nioro filler alloy during a third braze operation at 1800°F.

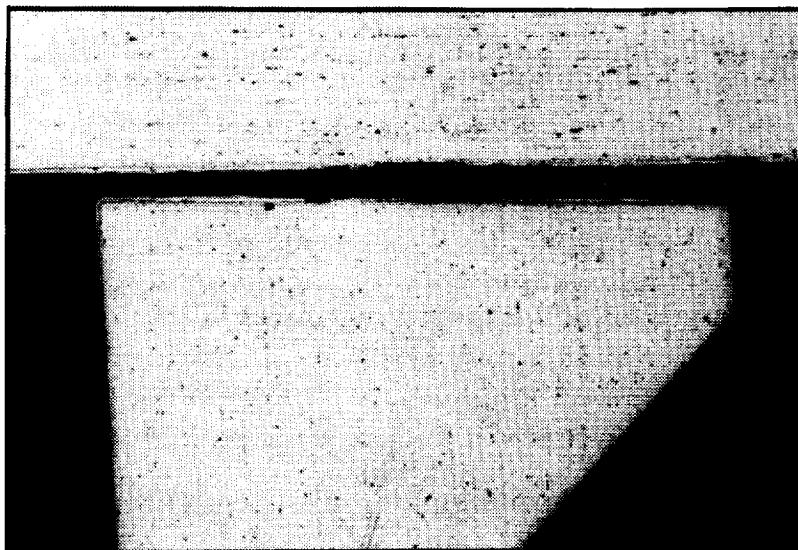
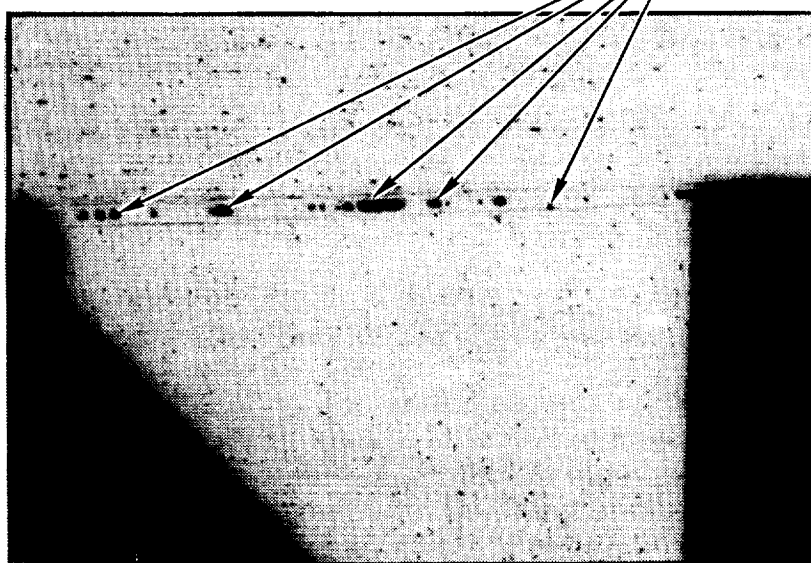
CROSS SECTIONS THROUGH BEAM 4

FRACTURED END
20X

POROSITIES IN
BRAZE FILLER ALLOY

UNFRACTURED END
20X

Metallurgical examination of the strut braze joints showed porosity, while the pressurized chamber braze joints are practically free of porosity. Braze joint cross sections are compared in Figures 30 and 31. This porosity reduced joint strength. In addition, enlarged, machined holes in the aft beam, to facilitate assembly of the fuel distribution tubes, resulted in increased local stresses that combined with the reduced strength to cause fracturing at a low pressure.

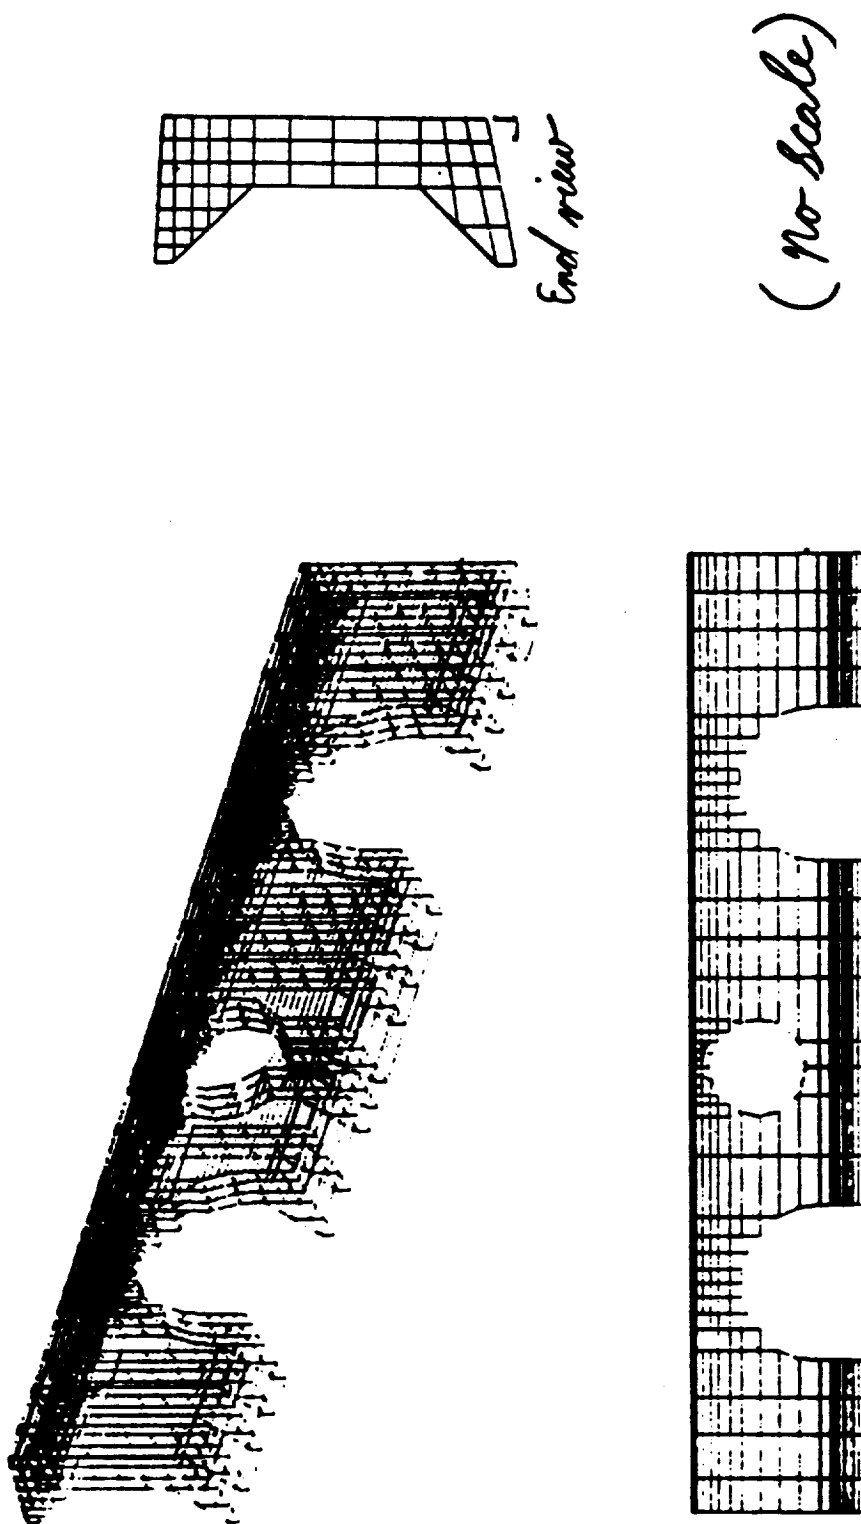
Figure 36. Three Views of ANSYS 3D Finite Element Model of a Portion of Beam 5

model stresses and deformations for similar sections are compared in Figures 39 and 40. Although the stress patterns in the 3D sections are similar to the 2D model stress patterns, the 3D model stresses are higher, and vary along the length, because of the hole and two arches that penetrate the beam. These penetrations also cause reduced beam stiffness, and the 2D model displacements applied to the 3D model result in a lower load per unit length; thus, the 3D model stresses must be increased by a factor to obtain magnitudes corresponding to an applied pressure load of 1000 psig.

The average loads per unit length for the two models were compared by considering the nodal forces at the braze joint boundaries. This comparison resulted in a factor of 1.86 that must be applied to the 3D model to obtain the same loading per unit length as for the 2D model with 1000-psig internal pressure. When this factor is applied, the peak stresses are as shown in Figures 41 and 42. These peak stresses will cause local yielding. They must be reduced to provide margins that accommodate variability which results in less than full design strengths. The strut pressure tests indicate that with full-strength braze joints (approximately double the strength actually obtained) a proof pressure of 1500 psig can indeed be sustained.

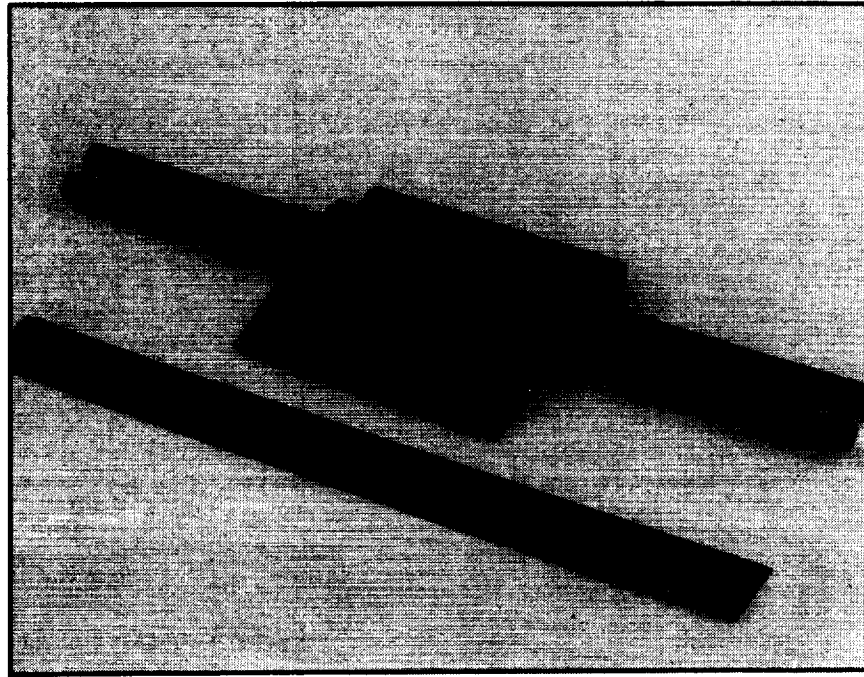
Figure 61. Manifolded Strut Leading Edge Specimen

The fourth specimen had manifolds added, as provided by the original design, to permit pressure testing.* Figure 61 shows the brazed assembly. The specimen was successfully pressure tested to 1500 psig and holographically examined in increments to 1250 psig. No joint voids were noted. Holograms at 1250 psig are shown in Figure 62.

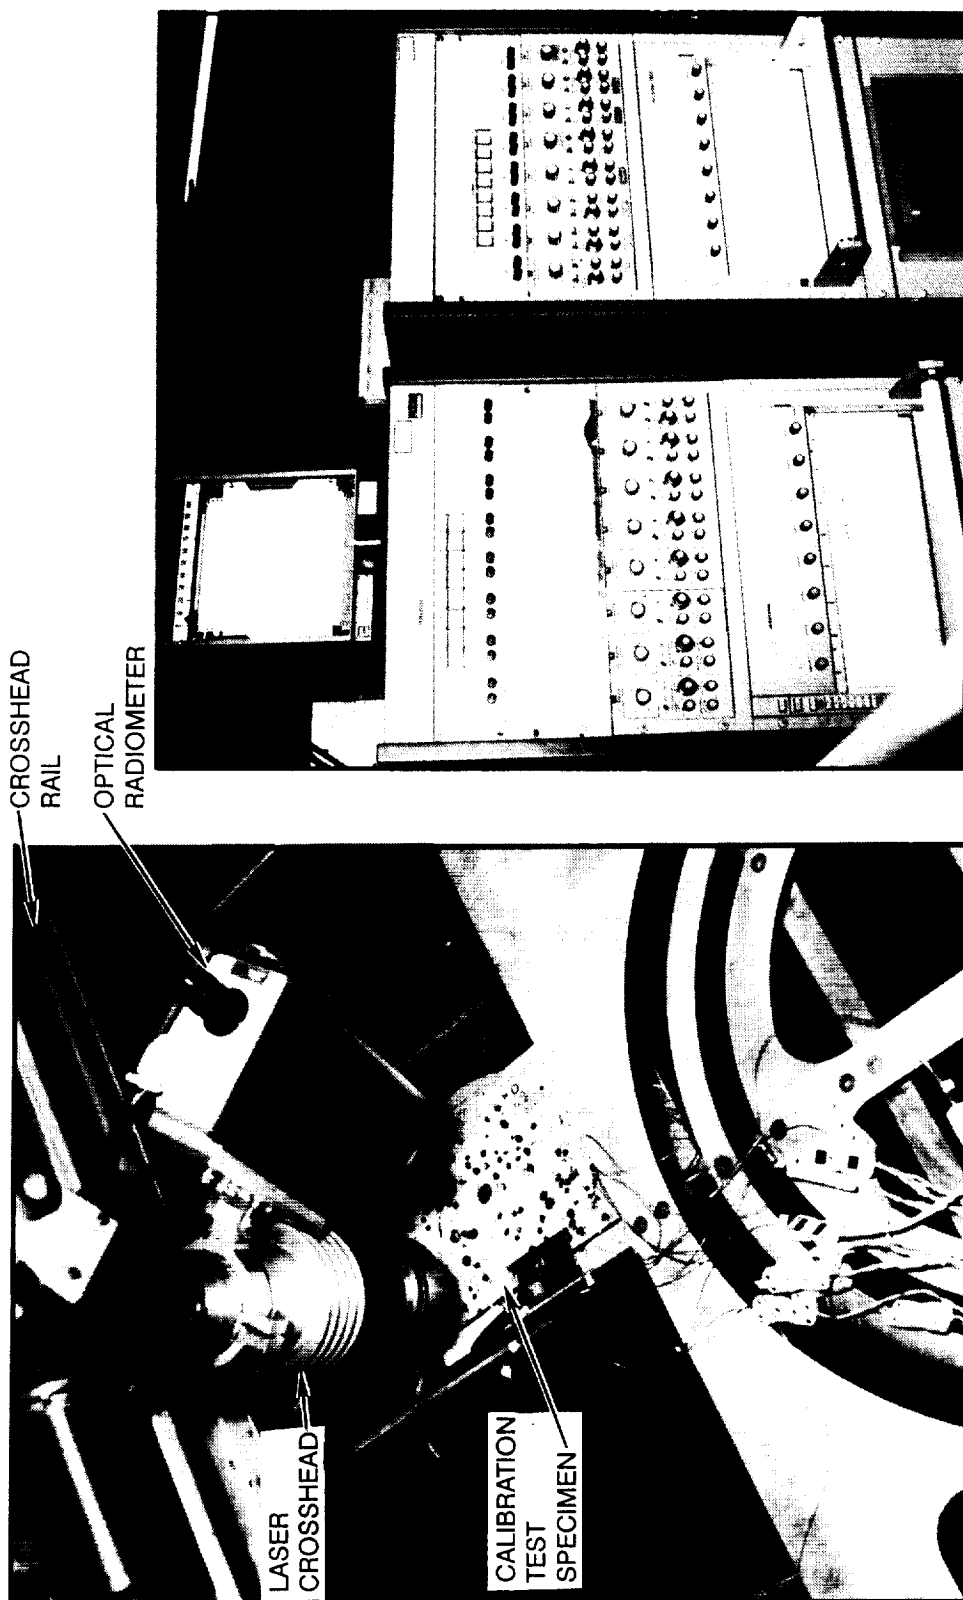
Figure 64. Laser Calibration Test Setup

loss from the heated area in the time interval required for the laser beam to repetitively impart energy to a point on the travel path; (2) The peak maximum temperature occurred at the ends of the heated length, where the beam momentarily stopped as the direction of travel was reversed. Masking that intercepts the laser beam at the ends of the travel was used to reduce this effect; (3) A constant energy input at a level required to obtain a 1400°F mean temperature resulted in a slowly rising mean temperature that preceded burnthrough. Examinations of the test pieces between runs have shown sites of incipient melting in the heated region when no excessive temperatures were recorded by the thermocouples. The surface temperature at the point of beam impingement was not directly measured by the thermocouples and was considerably hotter than the indicated value.

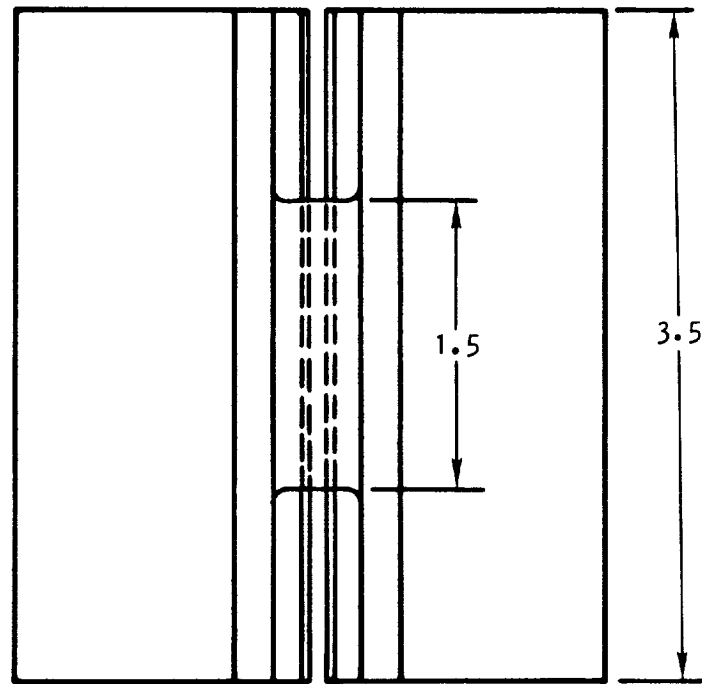
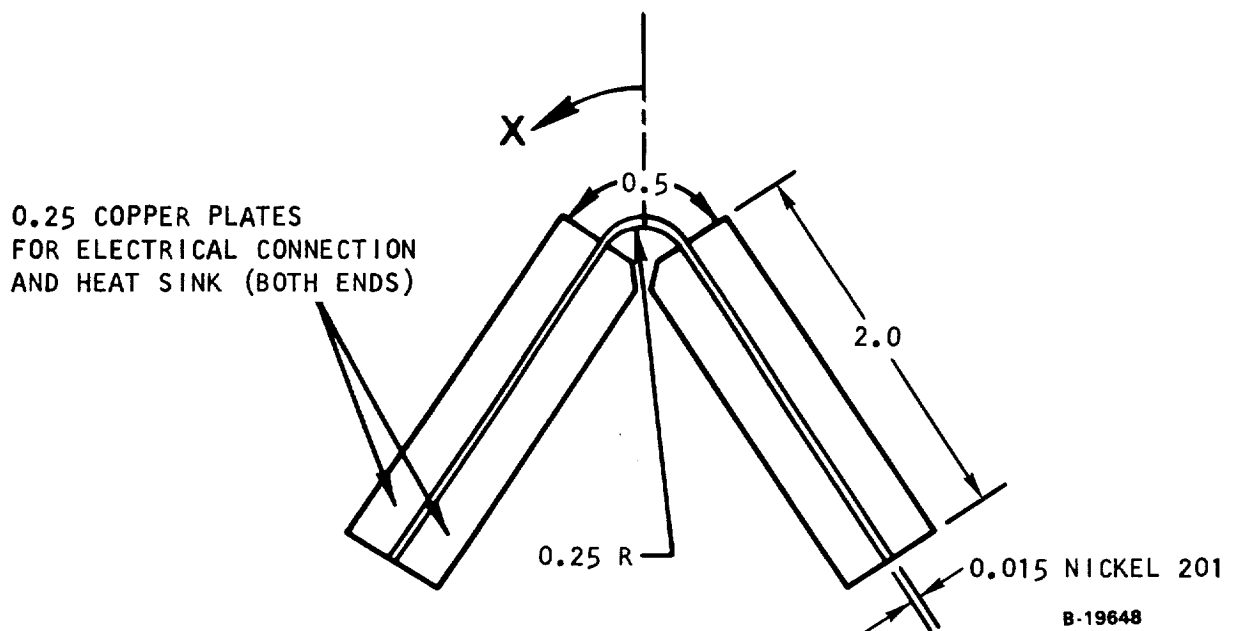
Figure 65. Electrical Resistance Heating Specimen for Combined Low Cycle Fatigue and Creep Testing

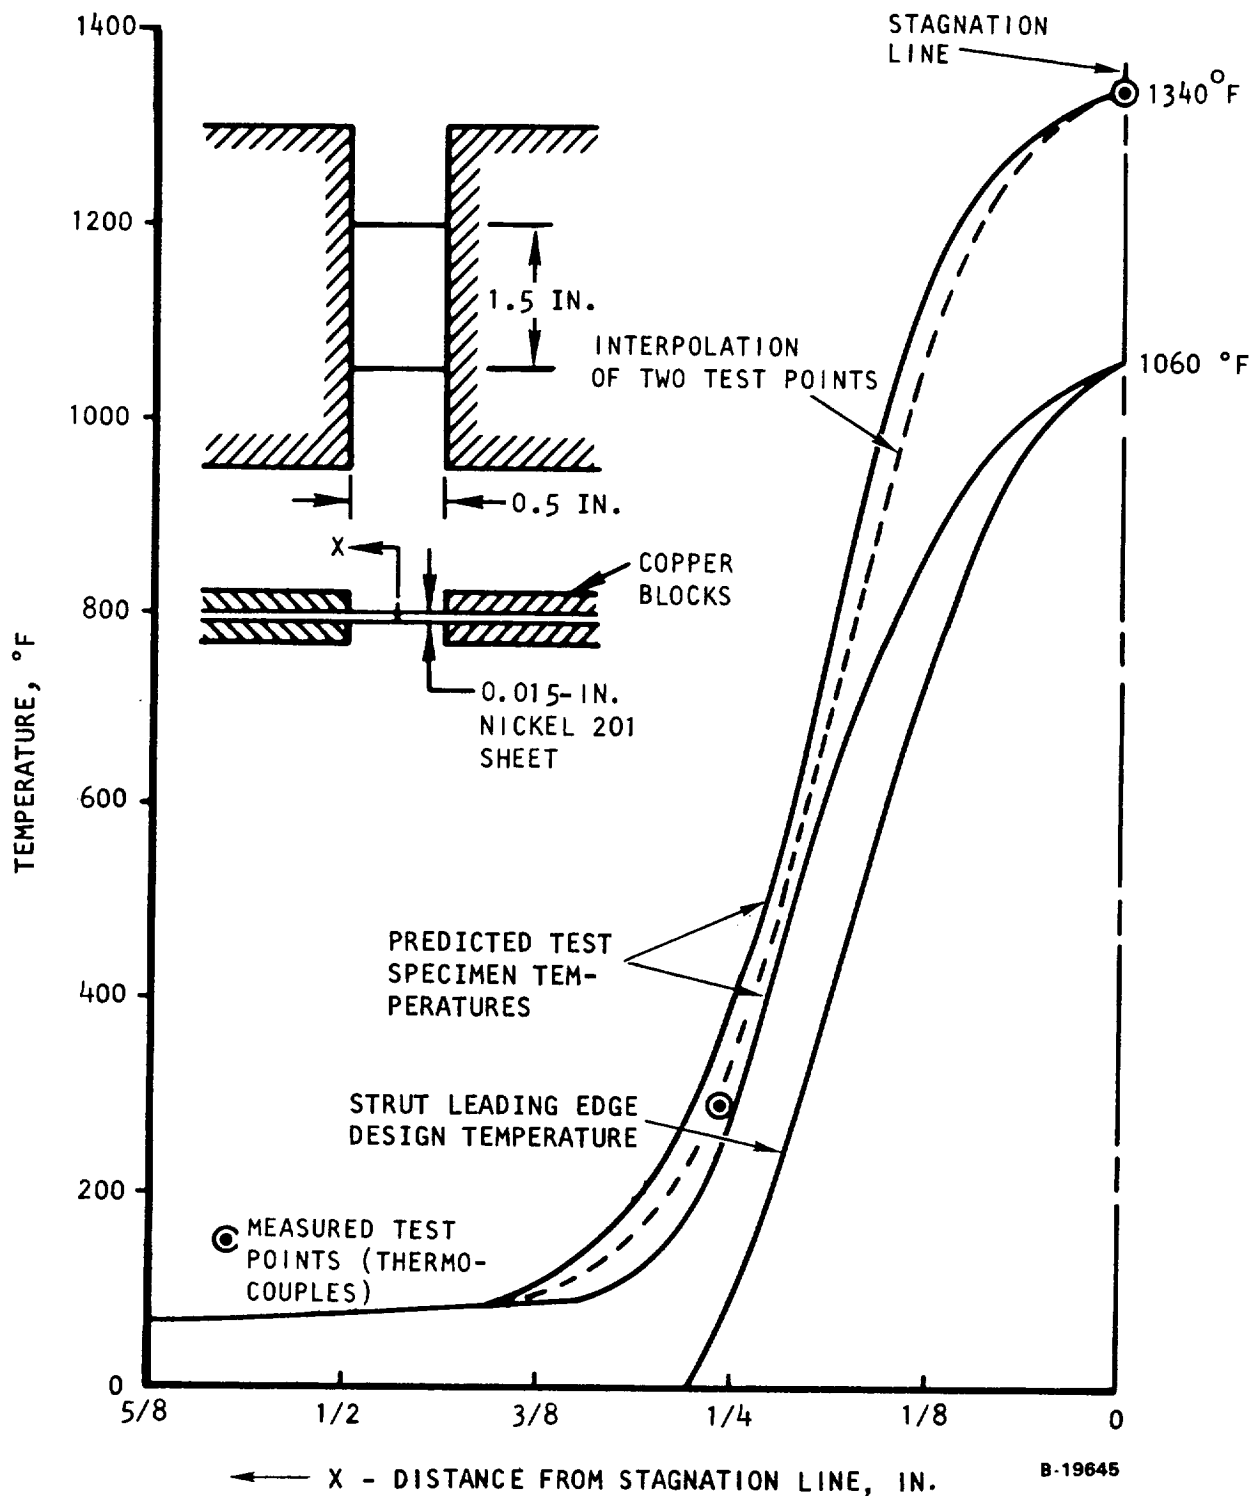
Figure 66. Strut Leading Edge LCF Test Specimen Temperature Distribution Using Electrical Resistance Heating
